NPS INVENTORY

National Park Service
Pacific Northwest Region
Cultural Resources Division

Shriner Peak Fire Lookout

MORA Cultural Resources Survey

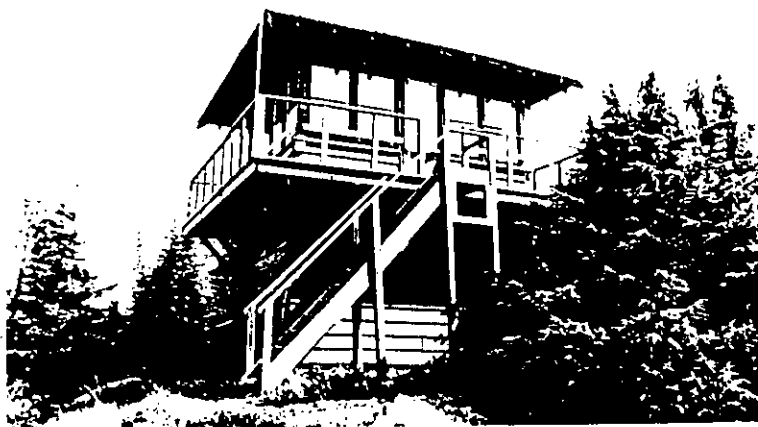
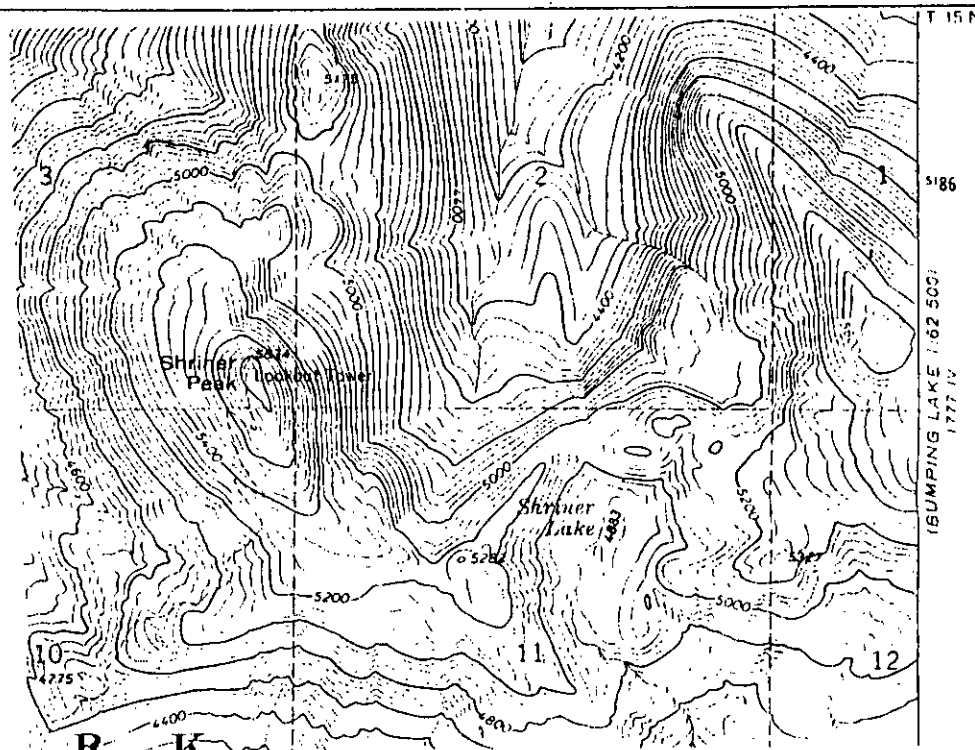
17 PHOTOS AND SKETCH MAP OF LOCATION

Timber frame, two-story, square plan; hip roof, cedar shingles, projecting eaves; wrap around balcony, fixed sashes, rough lapped (Douglas Fir) exterior siding; wood floors, tongue-and-groove interior walls and ceilings; concrete foundation.

☐ EXCELLENT☐ GOOD☒ FAIR☐ DETERIORATED☐ RUINS15. DANGER OF DEMOLITION?
(SPECIFY THREAT)☐ YES☐ NO☒ UNKNOWN
